# New Hampshire Volunteer Lake Assessment Program

## 2002 Interim Report for Robinson Pond Hudson

NHDES  
Water Division  
Watershed Management Bureau  
6 Hazen Drive  
Concord, NH 03301

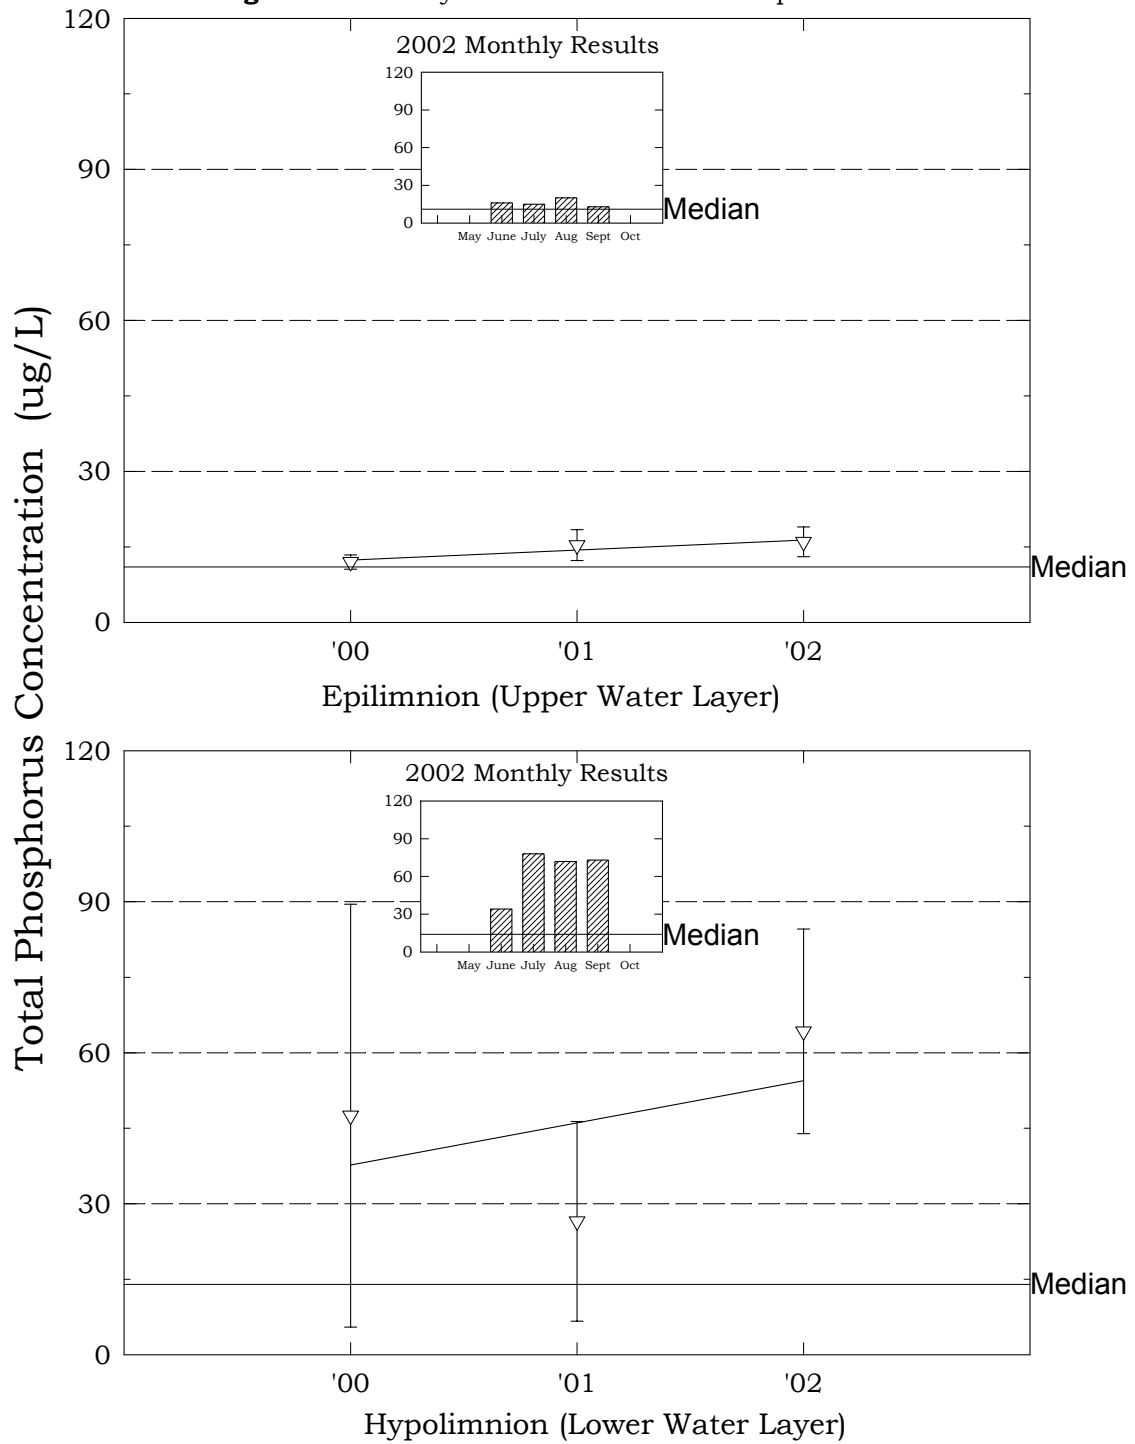
**Figure 3.** Monthly and Historical Total Phosphorus Data.

- **Figure 3 and Table 8:** The graphs in Figure 3 (Appendix A) show the amounts of phosphorus in the epilimnion (the upper layer) and the hypolimnion (the lower layer); the inset graphs show current year data. Table 8 (Appendix B) lists the annual maximum, minimum, and median concentration for each deep spot layer and each tributary since the lake/pond has joined the program.

The historical data for the epilimnion (upper layer) show that the 2002 total phosphorus mean is **slightly greater than** the state median.

The historical data for the hypolimnion (lower layer) show that the 2002 total phosphorus mean is **much greater than** the state median.

Overall, visual inspection of the historical data for the epilimnion shows **a slightly increasing** total phosphorus trend, which means that the concentration has **slightly worsened** in the epilimnion since monitoring began in 2000.

Overall, visual inspection of the historical data trend line for the hypolimnion shows **a variable, but overall increasing**, total phosphorus trend. This means that the concentration in the hypolimnion has **worsened** overall since monitoring began.

It is important to note that the total phosphorus concentration in the hypolimnion continues to be much greater than in the epilimnion. This suggests that the process of **internal total phosphorus loading** is occurring in the pond. Please refer to the explanation for Tables 9 and 10 for a more detailed explanation.

One of the most important approaches to reducing phosphorus loading to a waterbody is to continually educate watershed residents about its sources and how excessive amounts can adversely impact the ecology and value of lakes and ponds. Phosphorus sources within a lake or pond's watershed typically include septic systems, animal waste, lawn fertilizer, road and construction erosion, and natural wetlands. If you would like to educate watershed residents about how they can help to reduce phosphorus loading into the lake/pond, please contact the VLAP Coordinator.
